# **Aviation Occurrence Report**

ASC-AOR-16-06-001

**TransAsia Airways Flight GE235**

**Loss of Control and Crashed into Keelung River  
Three Nautical Miles East of Songshan Airport**

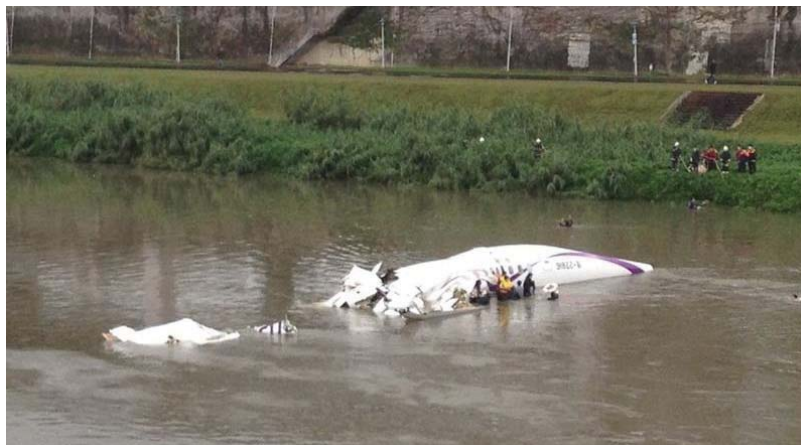
Figure 1.1-1 GE235 main wreckage

More than half of the main wreckage was submerged in the middle of the river (see Figure 1.1-1). As the aircraft flew over an overpass before impacting the water, its left wing collided with a taxi with two occupants. The taxi driver sustained serious injuries and the passenger sustained minor injuries.

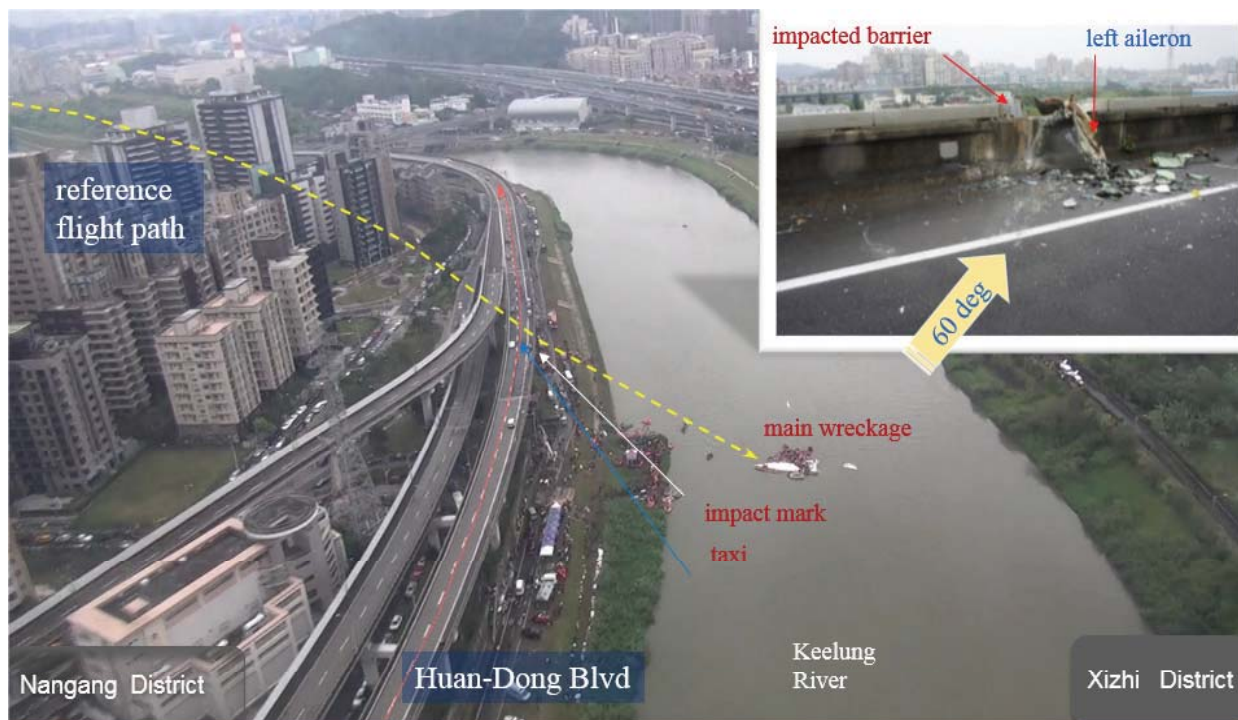
accident site. Keelung River is to the north side of the overpass. The depth of the river in this location is between one to two meters.

Figure 1.12-5 Aerial Photo of the GE235 crash site

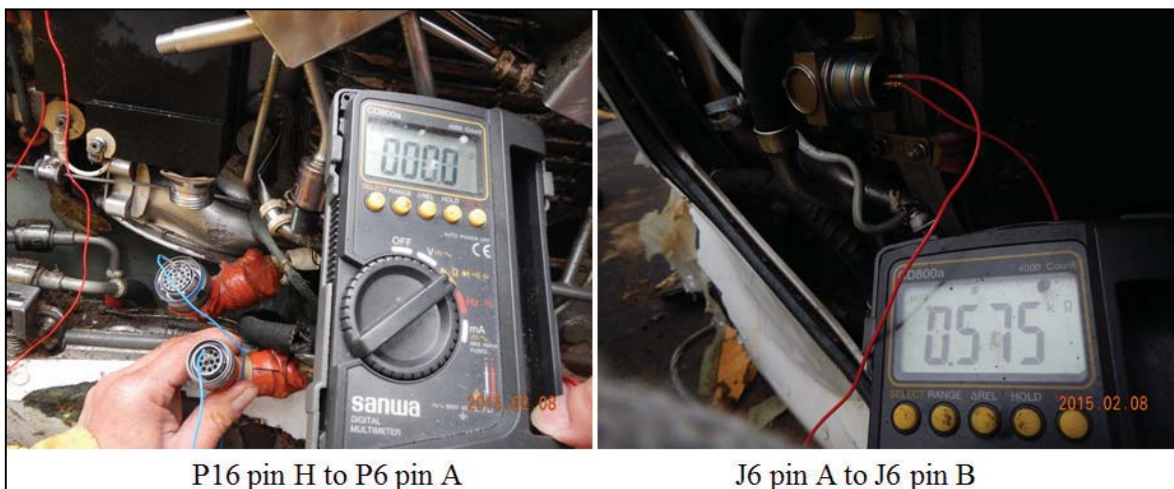
Point-A	Point-B	Expected	Result
J6 pin A	J6 pin B	553-589 ohms	575 ohms
P16 pin H	P6 pin A	0-0.5 ohms	0 ohm
P16 pin J	P6 pin B	0-0.5 ohms	0 ohm
Insulation resistance (with reference to ground) of torque sensor No. 1 > 2 Mohms

Figure 1.16-2 Continuity check of AFU No. 2 electrical circuit

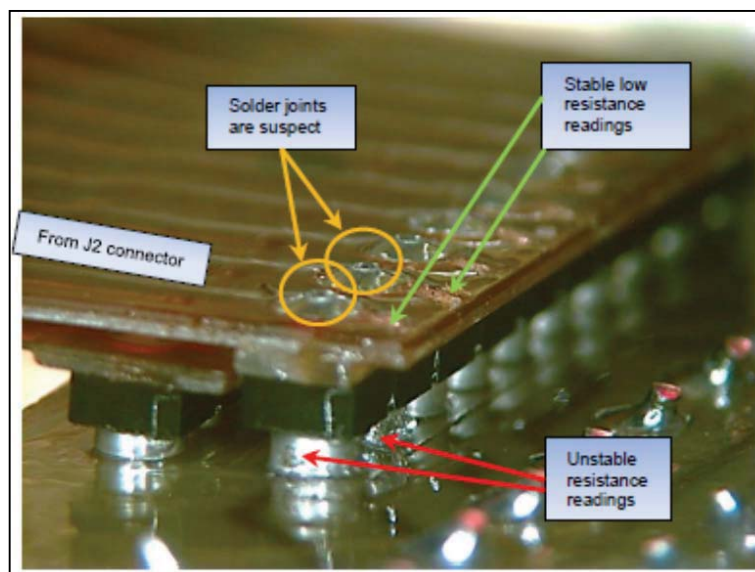
- The resistance ( $R_{X1}$ ) measured between pin J and point X1 provided a value consistent with the maximum resistance value provided by the CMM. Moving the ribbon did not affect this value.
- The resistance ( $R_{X2}$ ) measured between pin J and point X2 provided a value greater than  $R_{X1}$ , which was unstable and changed while the ribbon was moved.
- The resistance ( $R_{X3}$ ) measured between pin J and point X3 provided a value greater than  $R_{X1}$ , which was unstable and changed while the ribbon was moved.

Figure 1.16-3 Continuity check of pin J and A2 board

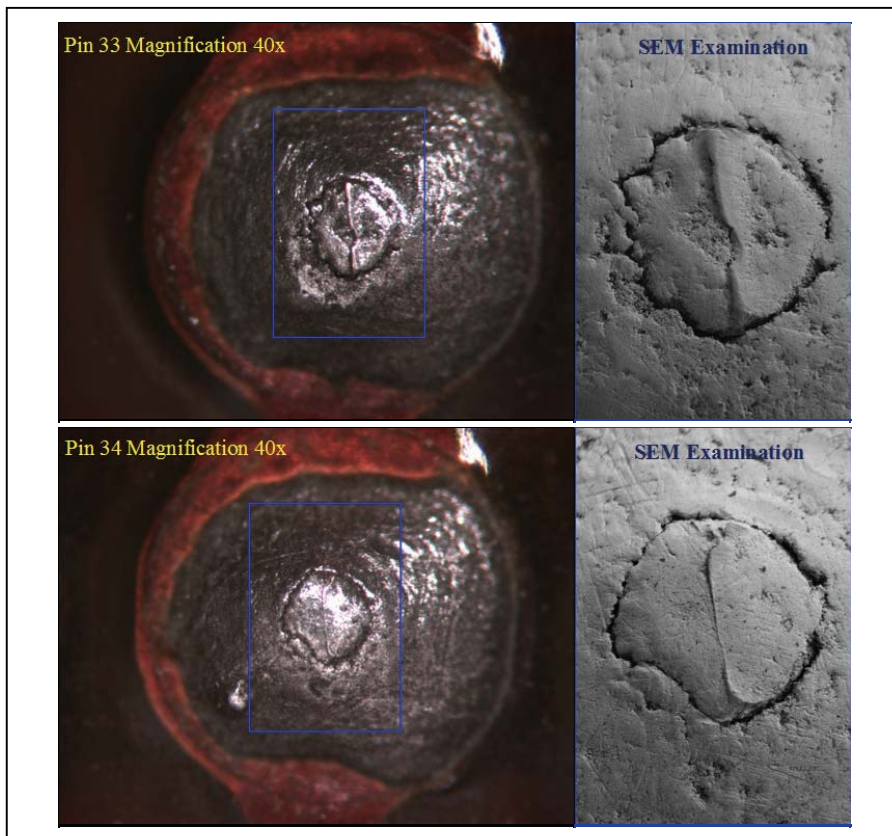
micro structure near the pin on each of the 10 pins in the strip. The condition was most advanced on pins near the end of the strip. The solder microstructure was consistent with enlargement, coarsening and cracking in a stress zone adjacent to the pin/solder interface. Away from this “stress zone” the solder microstructure was very fine.

Figure 1.16-4 Microscope (40X magnification) and SEM images for Pins 33 and 34.

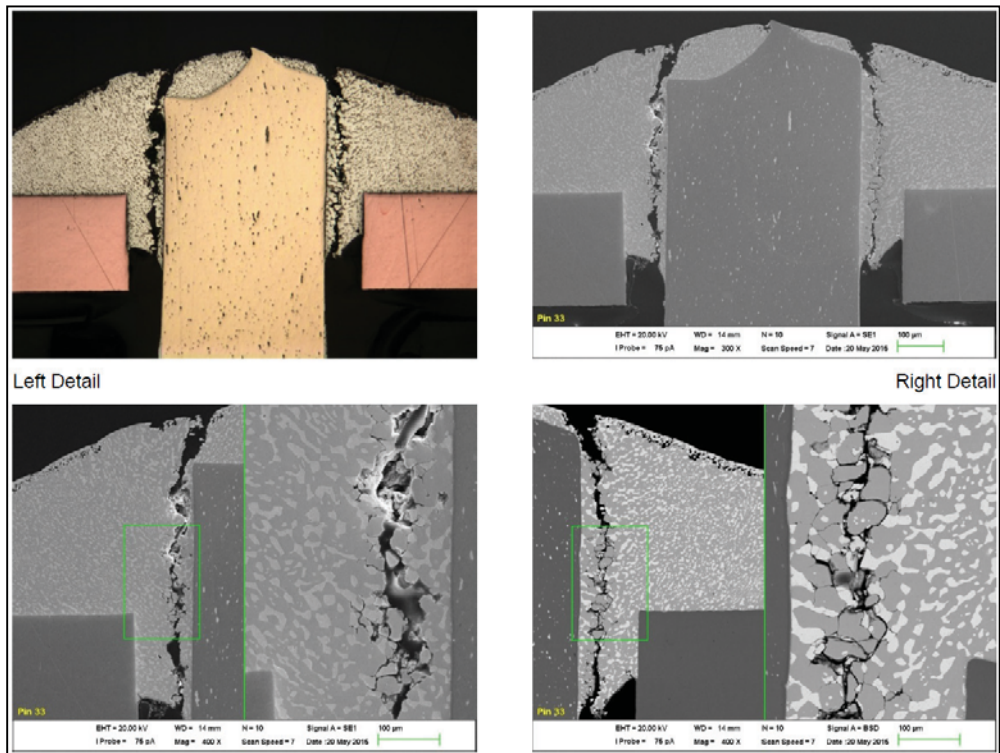
Figure 1.16-5 Cross sectioned pin to flex solder joints of pins 33

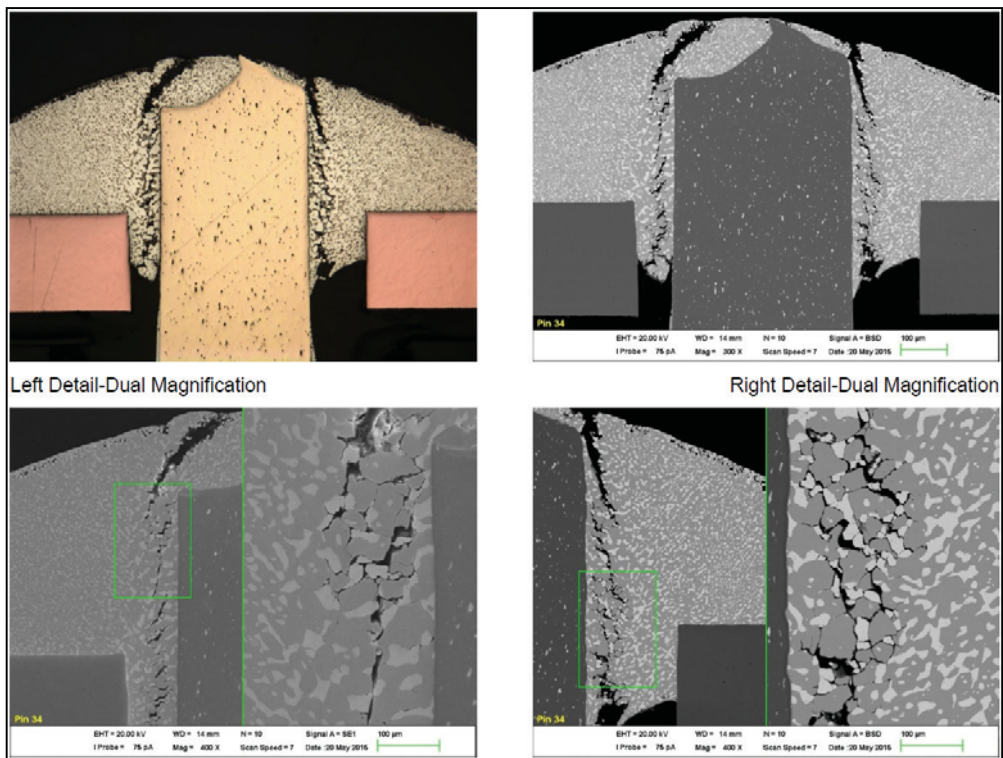
Figure 1.16-6 Cross sectioned pin to flex solder joints of pins 34

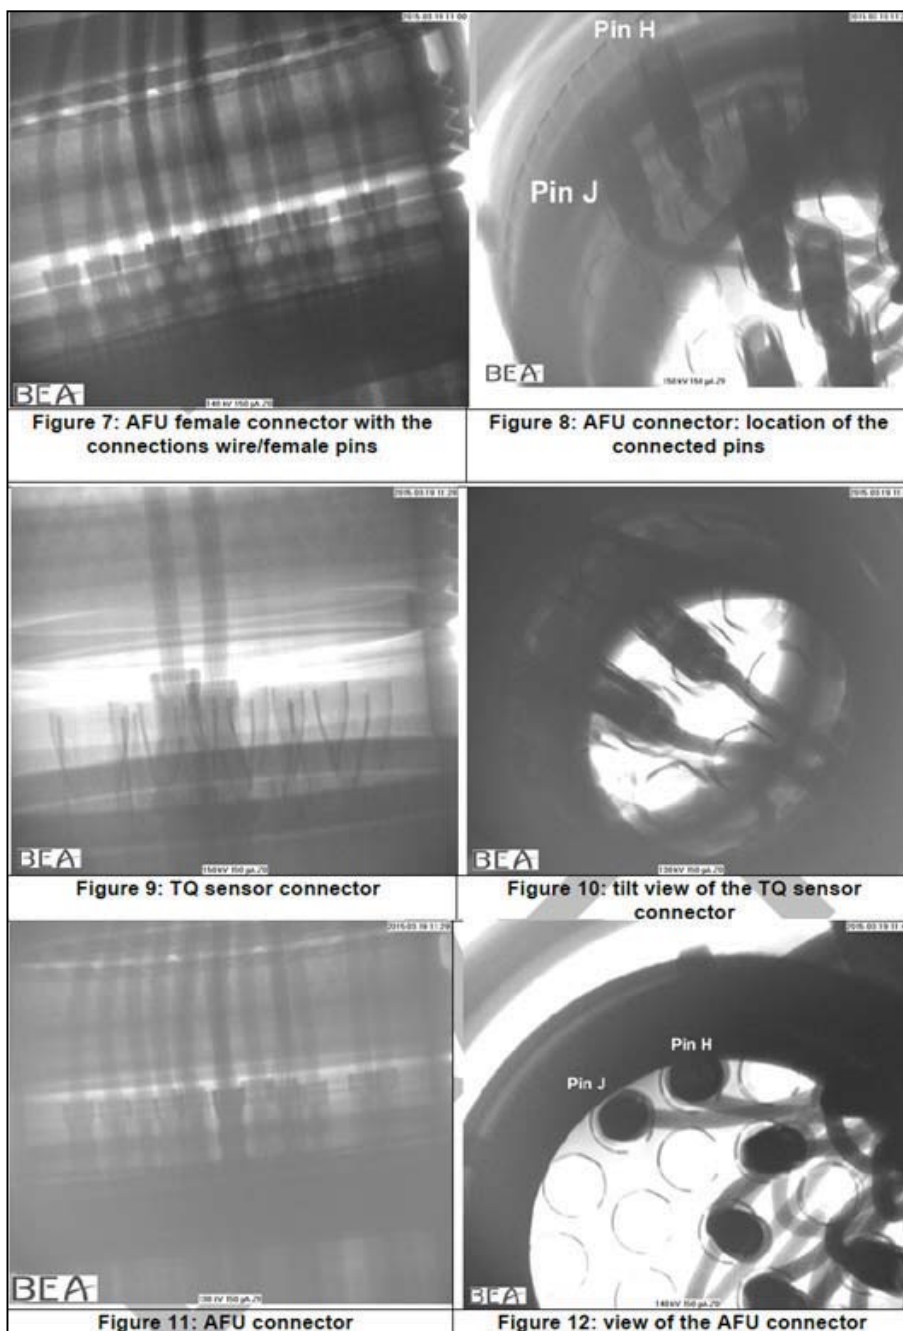
The X-ray examination of both harnesses showed no anomaly. The X-ray pictures of the connectors which connect AFU and the torque sensor of ENG 2 are shown in Figure 1.16-8.

Figure 1.16-8 X-ray examination of AFU and torque sensor connectors

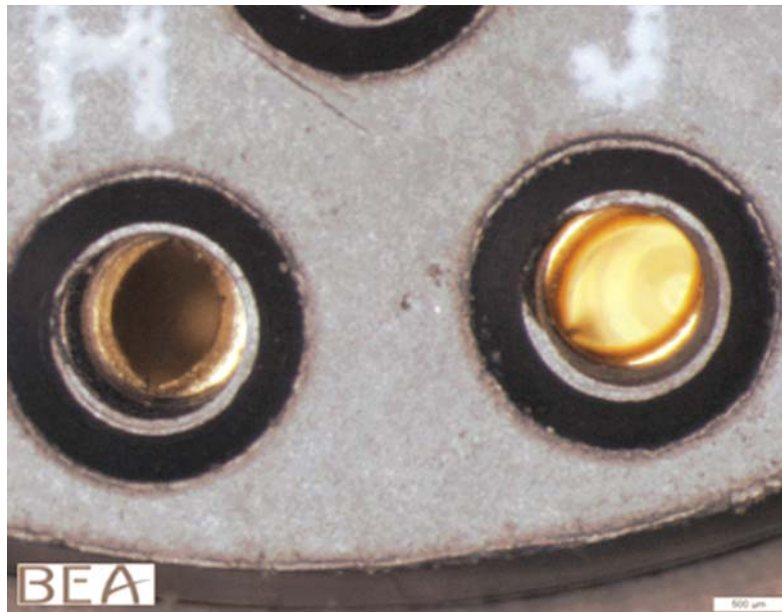
The macroscopic examination identified a difference between pin H on ENG 2 AFU connector and the other pins on that connector. Figure 1.16-9 shows AFU No.2 connector pins H and J.

Figure 1.16-9 Connector pins H (left) and J (right) of AFU No. 2

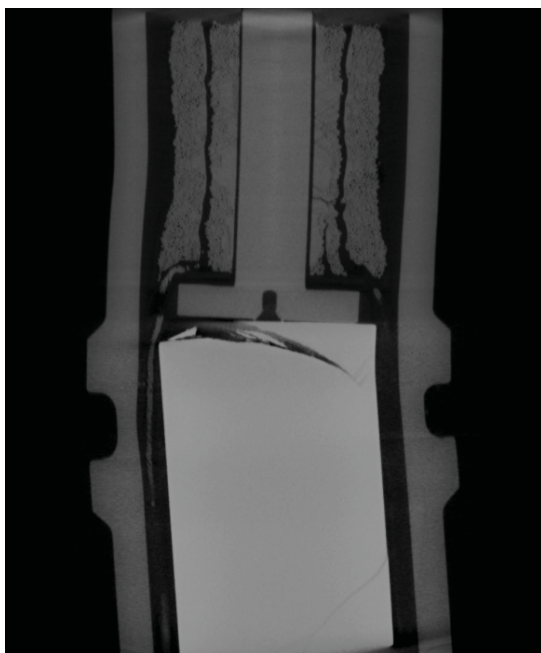
3D X-ray analysis (see Figure 1.16-11) of the sensor indicated that the coil wires had broken at the outside of the bend due to the impact.

Figure 1.16-11 3D X-ray view of ENG 2 torque sensor left S/N CH1468
