# **Aviation Occurrence Report**

ASC-AOR-16-06-001

**TransAsia Airways Flight GE235**

**Loss of Control and Crashed into Keelung River  
Three Nautical Miles East of Songshan Airport**

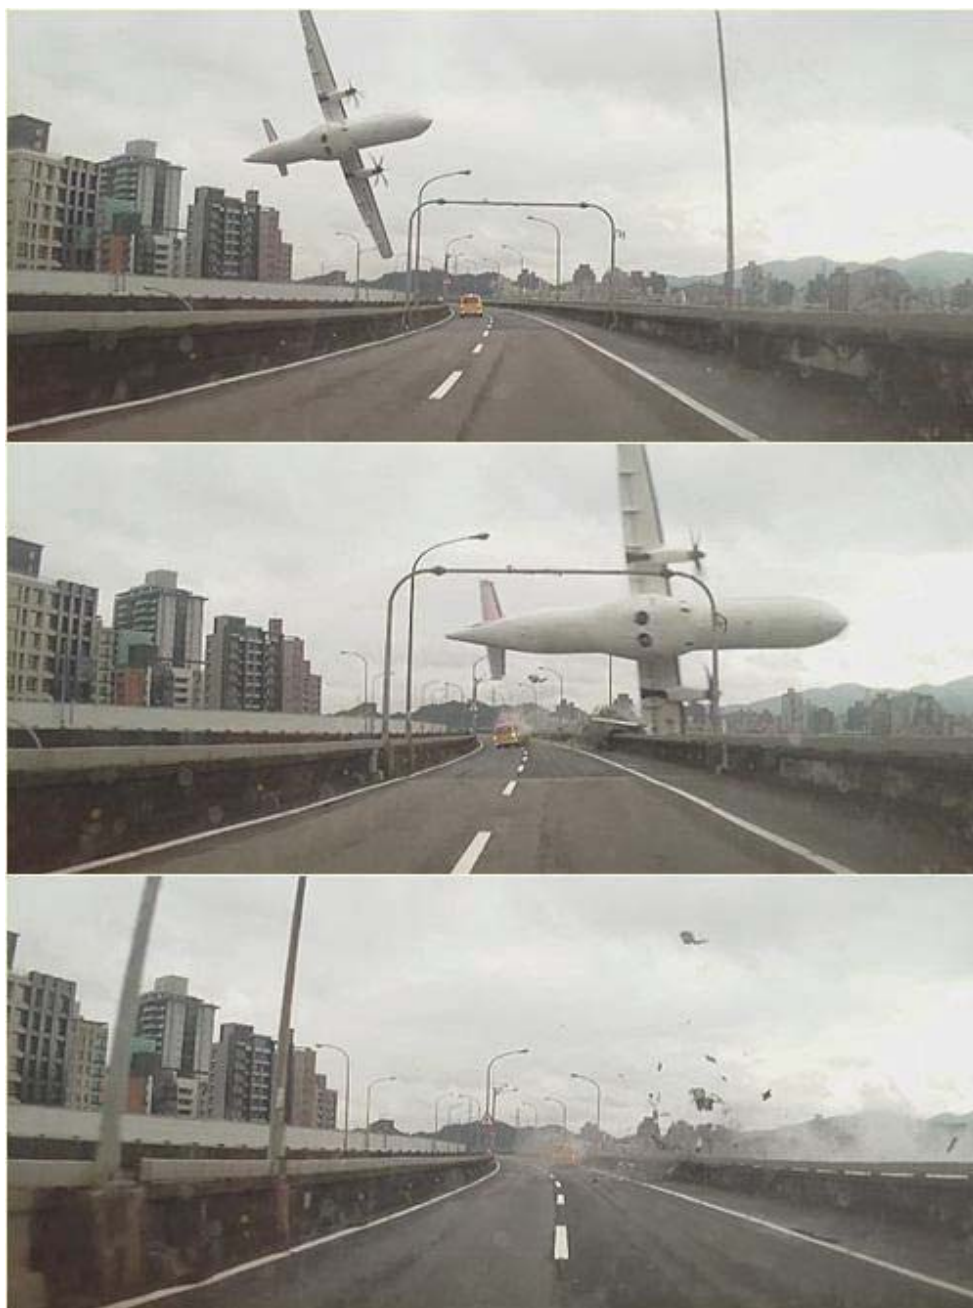
At 1054:34, the enhanced ground proximity warning system (EGPWS) “pull-up” warning was annunciated in the cockpit. At 1054:35 the aircraft’s left bank angle increased from 10 to 80 degrees. The aircraft’s left wing then collided with a taxi driving on the overpass. The wing then impacted the fence and a light pole at the edge of the overpass located southwest of the Keelung river occurrence site (see Figure 1.1-2). The aircraft continued to bank to the left after those collisions and then entered the river inverted.

Figure 1.1-2 GE235 loss of control and initial impact sequence.

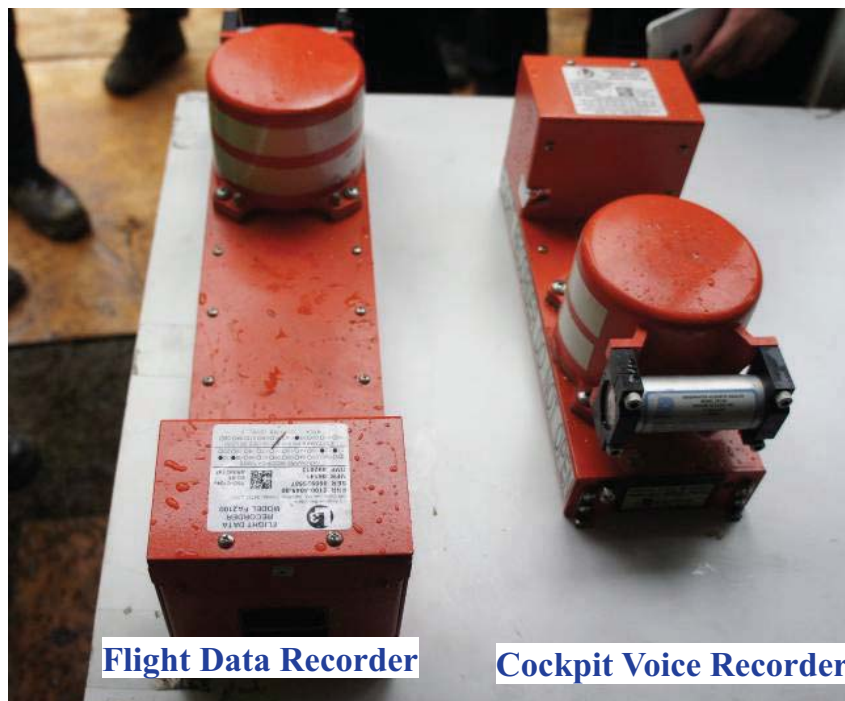
The flight data recorder (FDR) and the cockpit voice recorder (CVR) were recovered by the ASC investigators at 1605 on the occurrence day. Both recorders were immersed in water but exhibited no external damage. The recovered CVR and FDR are shown in Figure 1.11-1.

Both recorders were transported to the ASC Investigation Laboratory for disassembling and readout on 4 February. The crash survival memory units (CSMU) of both the CVR and FDR were in good condition. After cleaning and drying the CSMUs, data from both recorders were successfully downloaded.

Figure 1.11-1 External view of the FDR and CVR

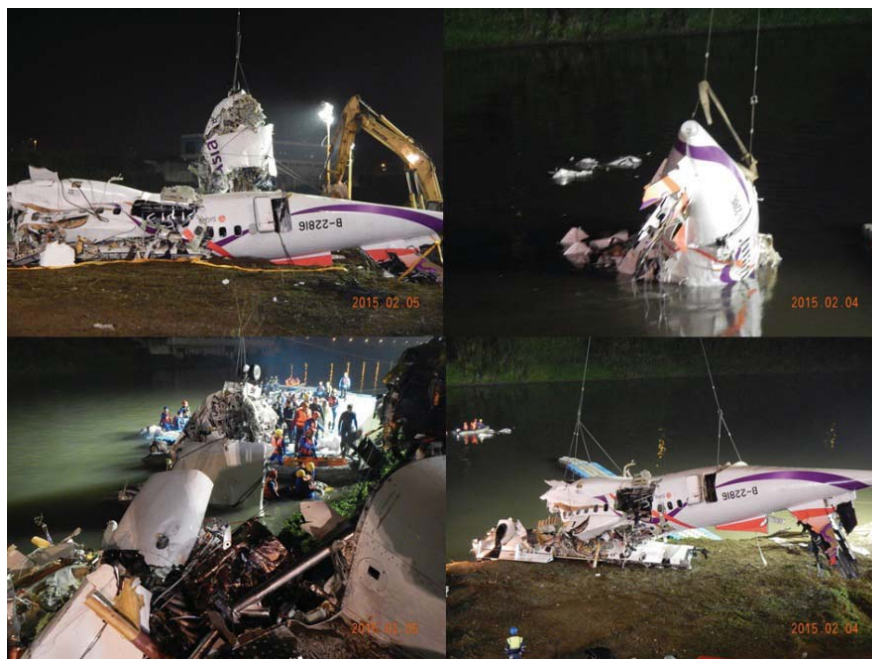
The primary aircraft wreckage consisted of two major separated sections of the airframe: the cockpit section; and the middle/aft section of the fuselage. The nose of the aircraft was embedded in the mud of the riverbed. A floating bridge and three heavy lift vehicles were deployed by the Army Engineering Corps to facilitate the recovery of the deceased passengers and salvage of the aircraft wreckage. The salvage of the aircraft wreckage commenced after the search and rescue operation had recovered all surviving passengers and crew. Figure 1.12-1 depicts the initial salvage of the two major portions of the aircraft wreckage. The major portions of aircraft wreckage, including the remnants of the engines and propellers, were successfully recovered by the late afternoon of the second day of the salvage operation.

Figure 1.12-1 Wreckage recovery operations

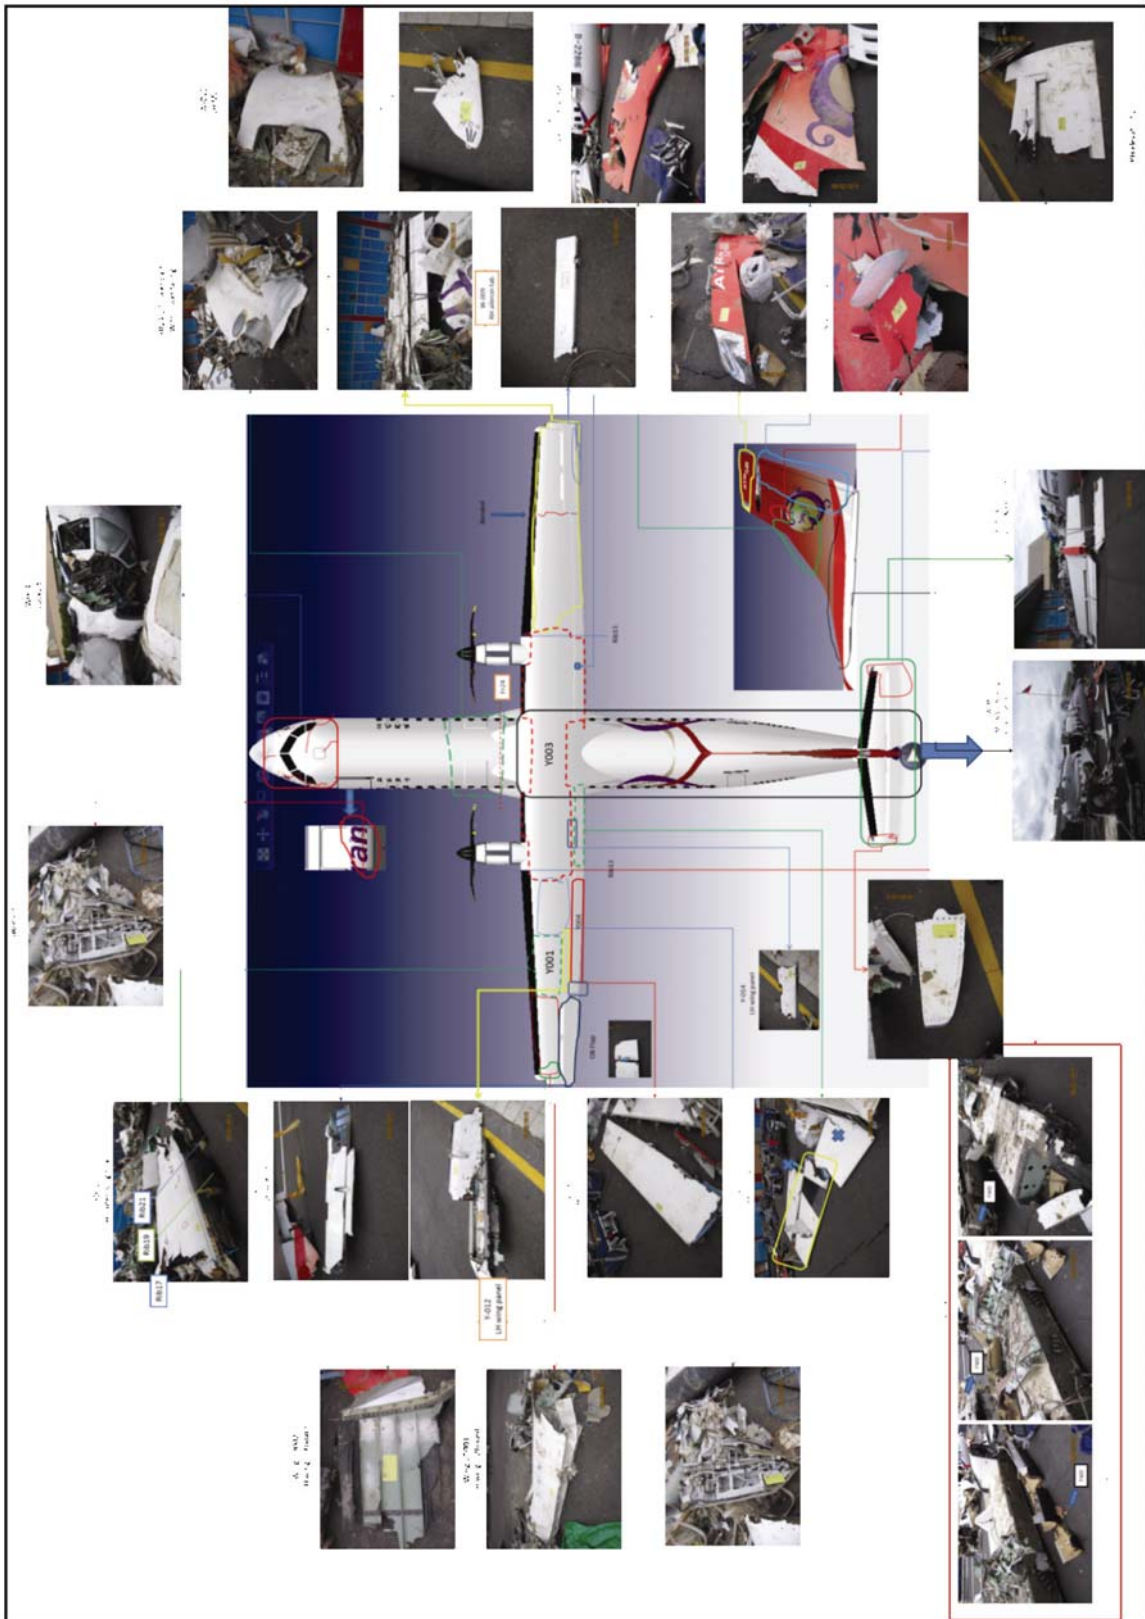
Figures 1.12-2 and 1.12-3 identify and map the major sections and components of the aircraft that were recovered. The recovered wreckage represented approximately 85% of the whole aircraft. The remaining unrecovered 15% of the aircraft was primarily in the area aft of the cargo area and forward of the ice shield area.

Figure 1.12-2 Recovered aircraft wreckage (1)

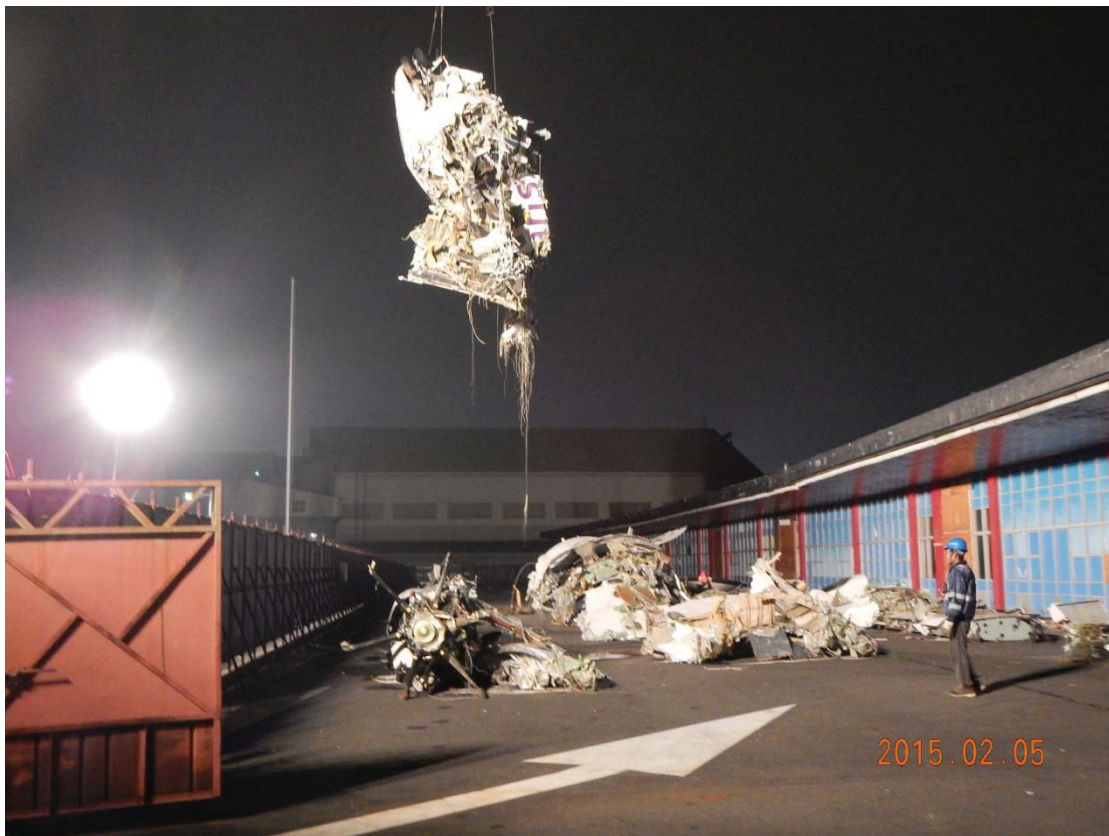
Figure 1.12-4 shows the aircraft cockpit portion being lifted and moved to the wreckage storage site. The aircraft wreckage was arranged to represent as much as possible a reconstruction of the aircraft.

Figure 1.12-4 Wreckage storage site

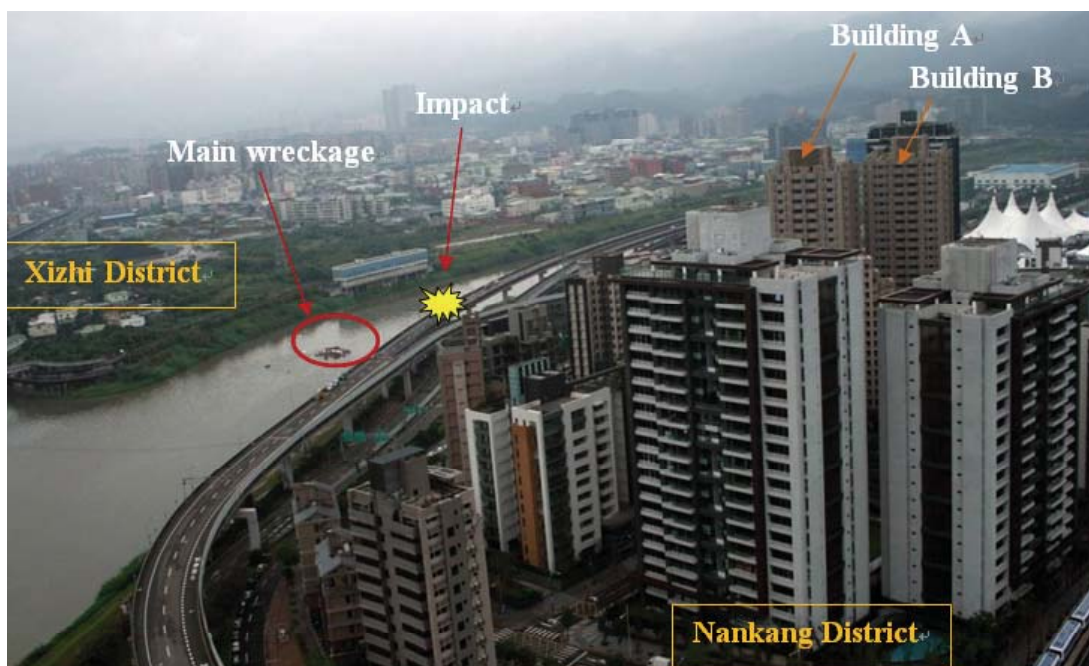
Figure 1.12-7 Aerial photo of occurrence site taken from a rescue helicopter

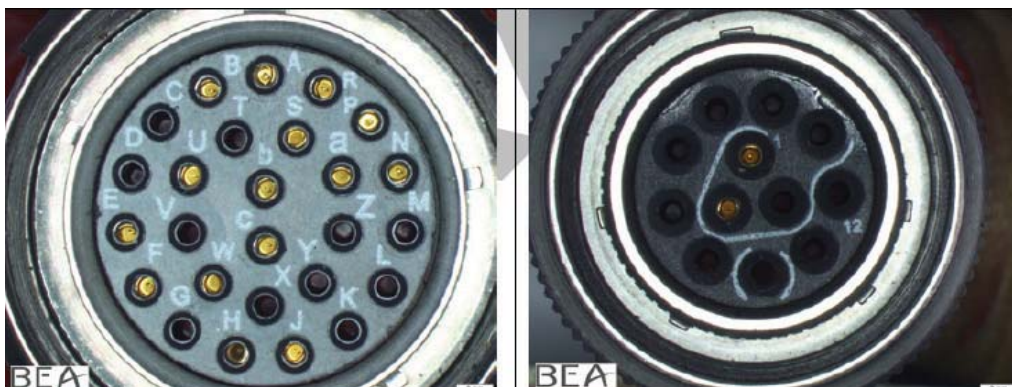
The wiring harnesses connecting the No. 1 torque sensors to the AFUs of both engines were removed from the occurrence aircraft and dispatched to BEA for further examination. A visual or macroscopic inspection and X-ray examination were conducted. The connection between the torque sensor and the AFU was achieved through (see Figure 1.16-7):

Figure 1.16-7 Connectors of AFU (left) and torque sensor (right)

The X-ray examination of both harnesses showed no anomaly. The X-ray pictures of the connectors which connect AFU and the torque sensor of ENG 2 are shown in Figure 1.16-8.

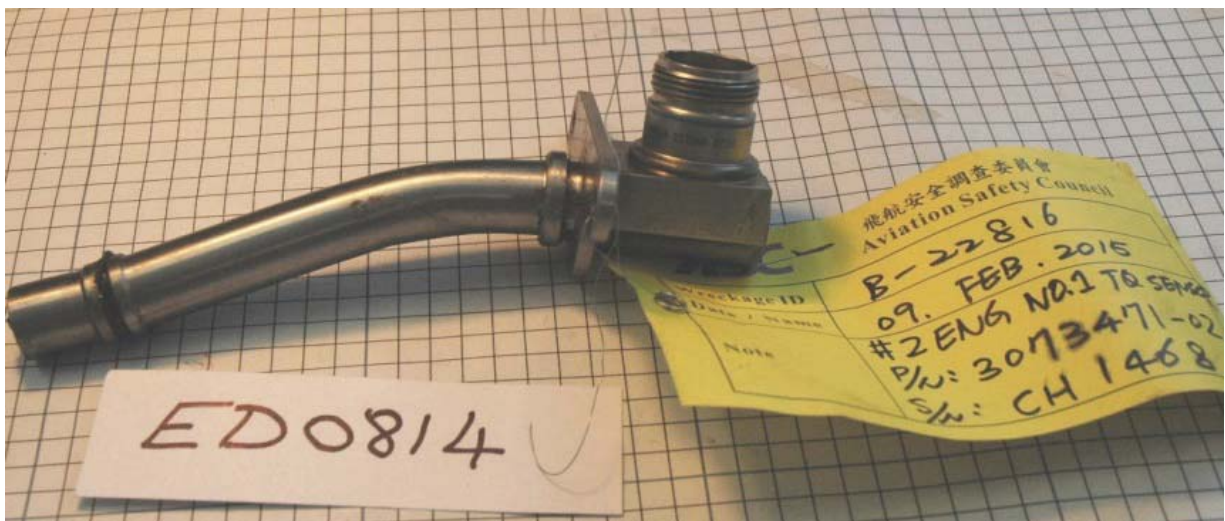
Figure 1.16-10 External view of ENG 2 torque sensor left S/N CH1468

3D X-ray analysis (see Figure 1.16-11) of the sensor indicated that the coil wires had broken at the outside of the bend due to the impact.

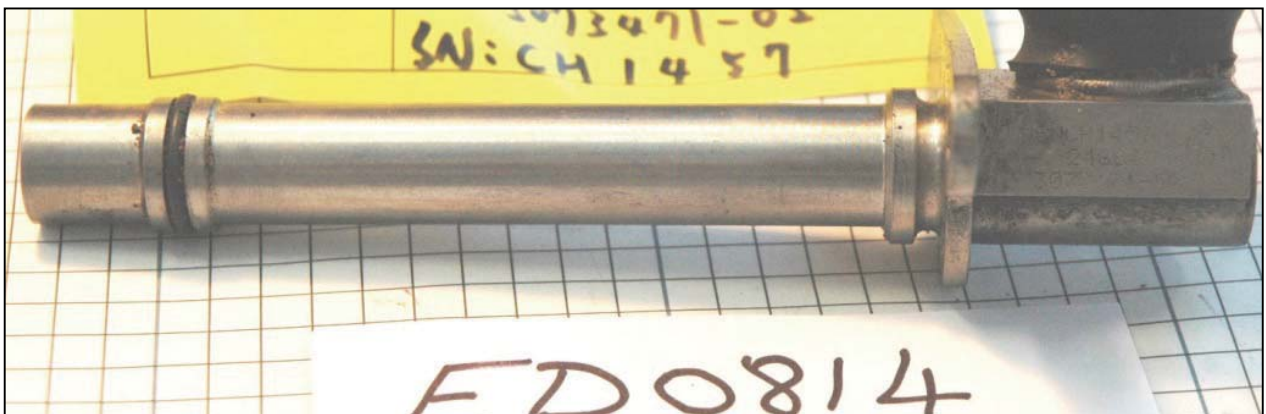
Figure 1.16-12 External view of ENG 2 torque sensor right S/N CH1457

Dark residue was present on the torque sensor junction-box. There was a small amount of dark residue and contact marks on the probe tip. The end of the wiring harness was attached to the electrical connector and secured with a heat-shrink sleeve. The packing was present on the tip and appeared to be intact. Following removal of the wiring harness a small amount of clear liquid was observed inside the sensor electrical connector. Iron-oxide with traces of silicon and aluminum were identified on the probe tip.

- Test point 6.3 Dynamic test: with the sensor installed with an air gap of 0.035in from the phonic-wheel, and the wheel speed set at 4263 RPM the voltage between pin 1 and 2 was 8.5 volts peak-to peak. This was slightly below the test point minimum limit of 8.9 volts peak-to peak.
